ACTION MEMORANDUM

SUBJECT: Approval and Funding for a Removal Action at the Red and Bonita Mine Site in San Juan County, Approximately Seven Miles North of Silverton, Colorado.

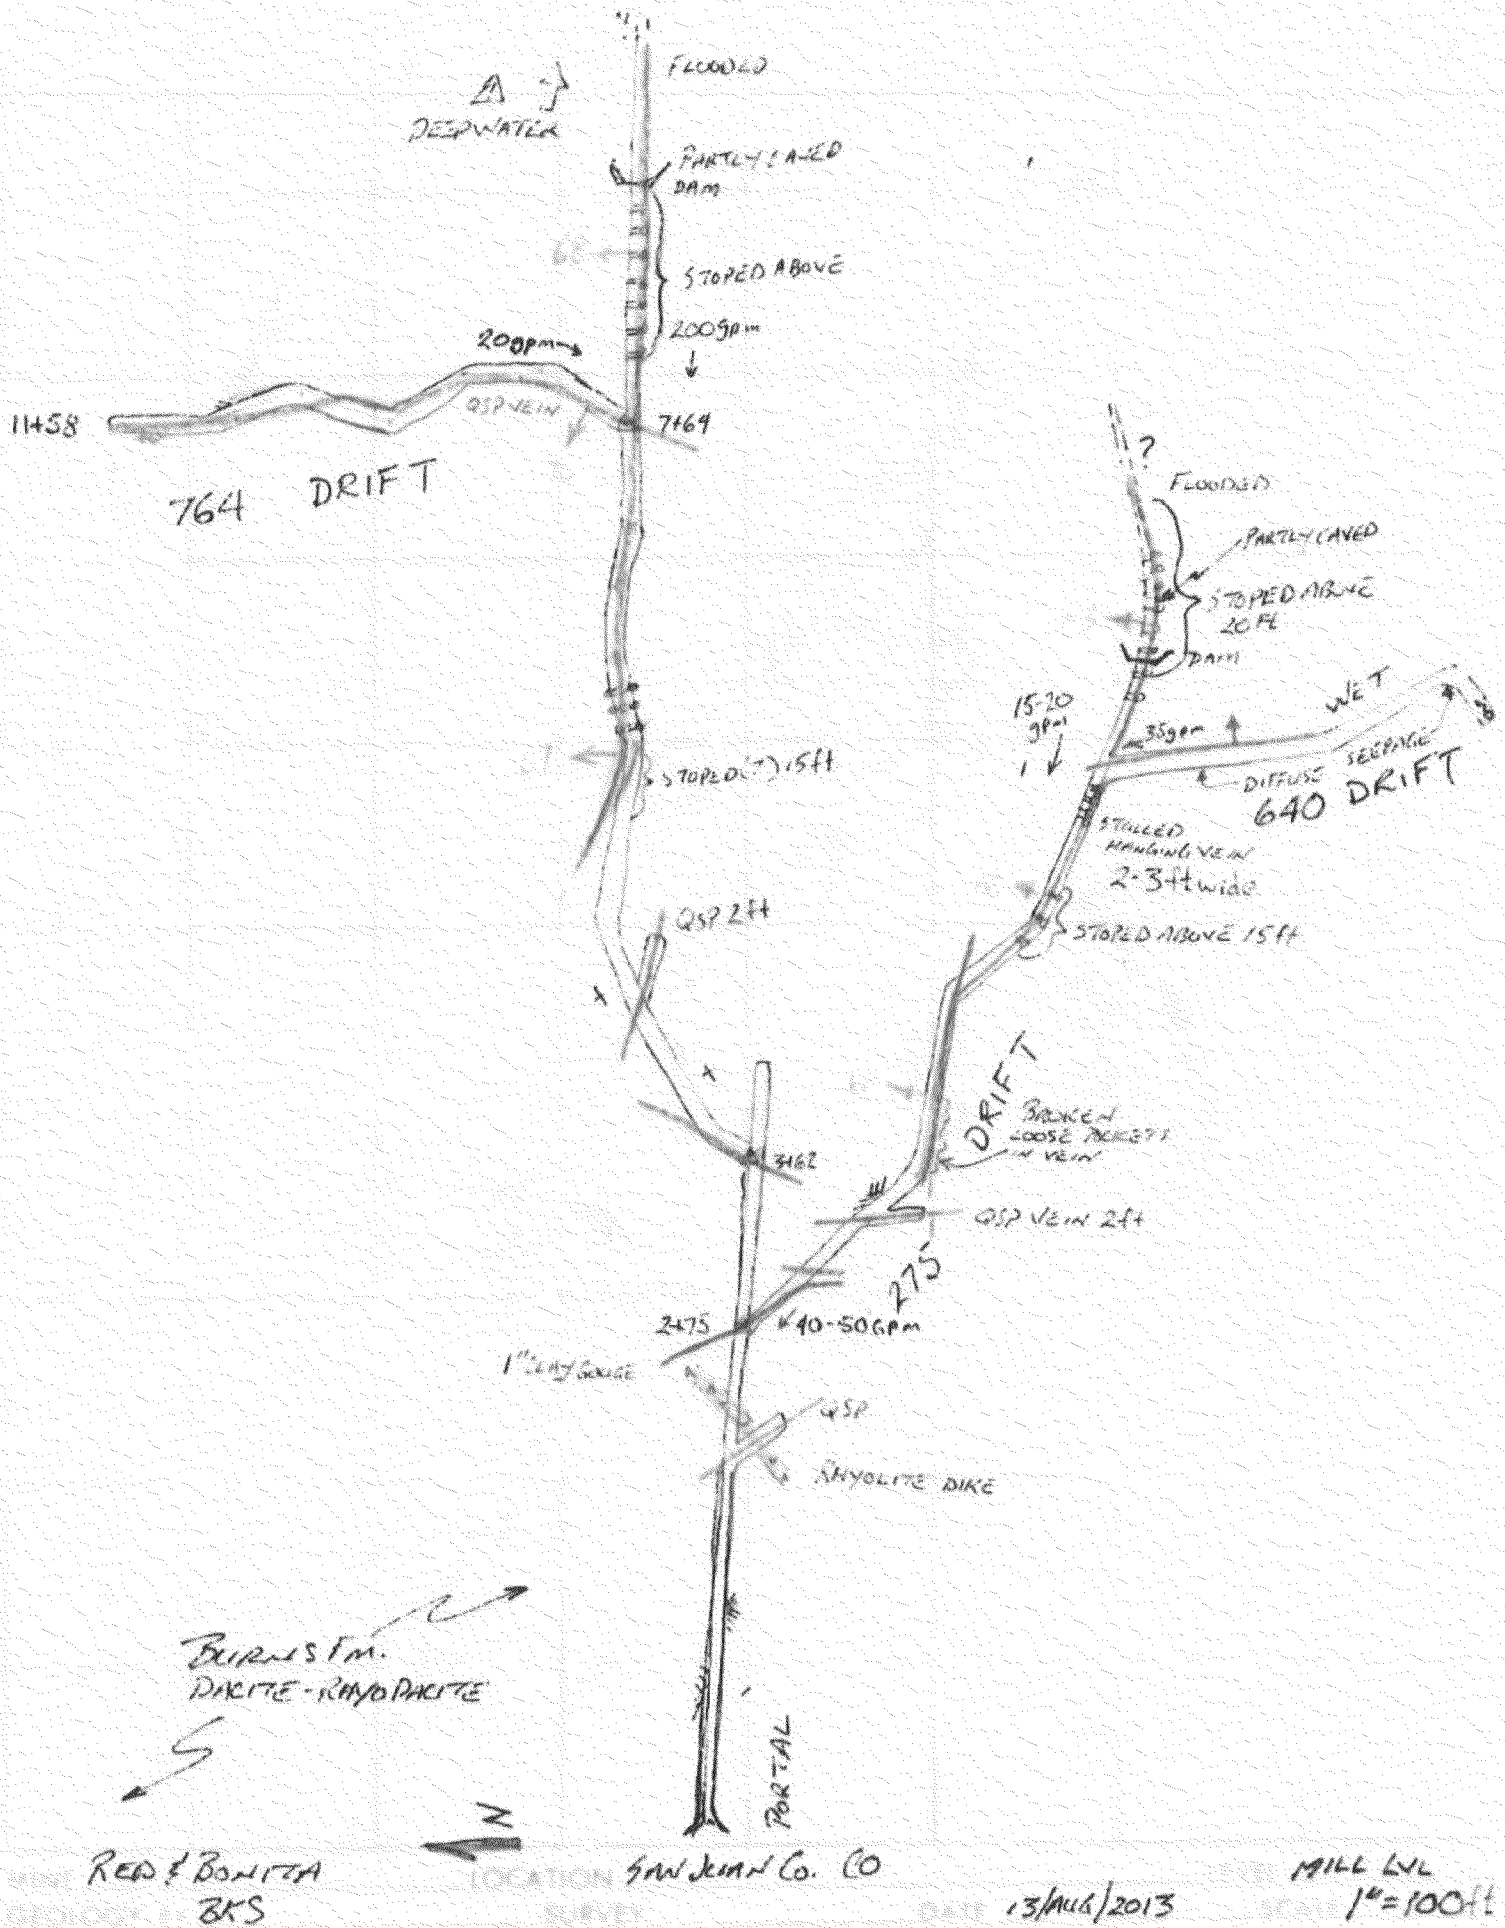
In September/October 2011, the EPA removed blockage in the Red and Bonita Mine opening and constructed a temporary portal for accessing the mine. The mine adit is approximately five feet wide by seven feet high and extends underground for several hundred feet in multiple directions (Attachment 1-Figure 2). Investigations of the mine allowed access to approximately 2,000 feet of workings. Collapsed ground within the tunnels prevented further investigation. However, based on historic

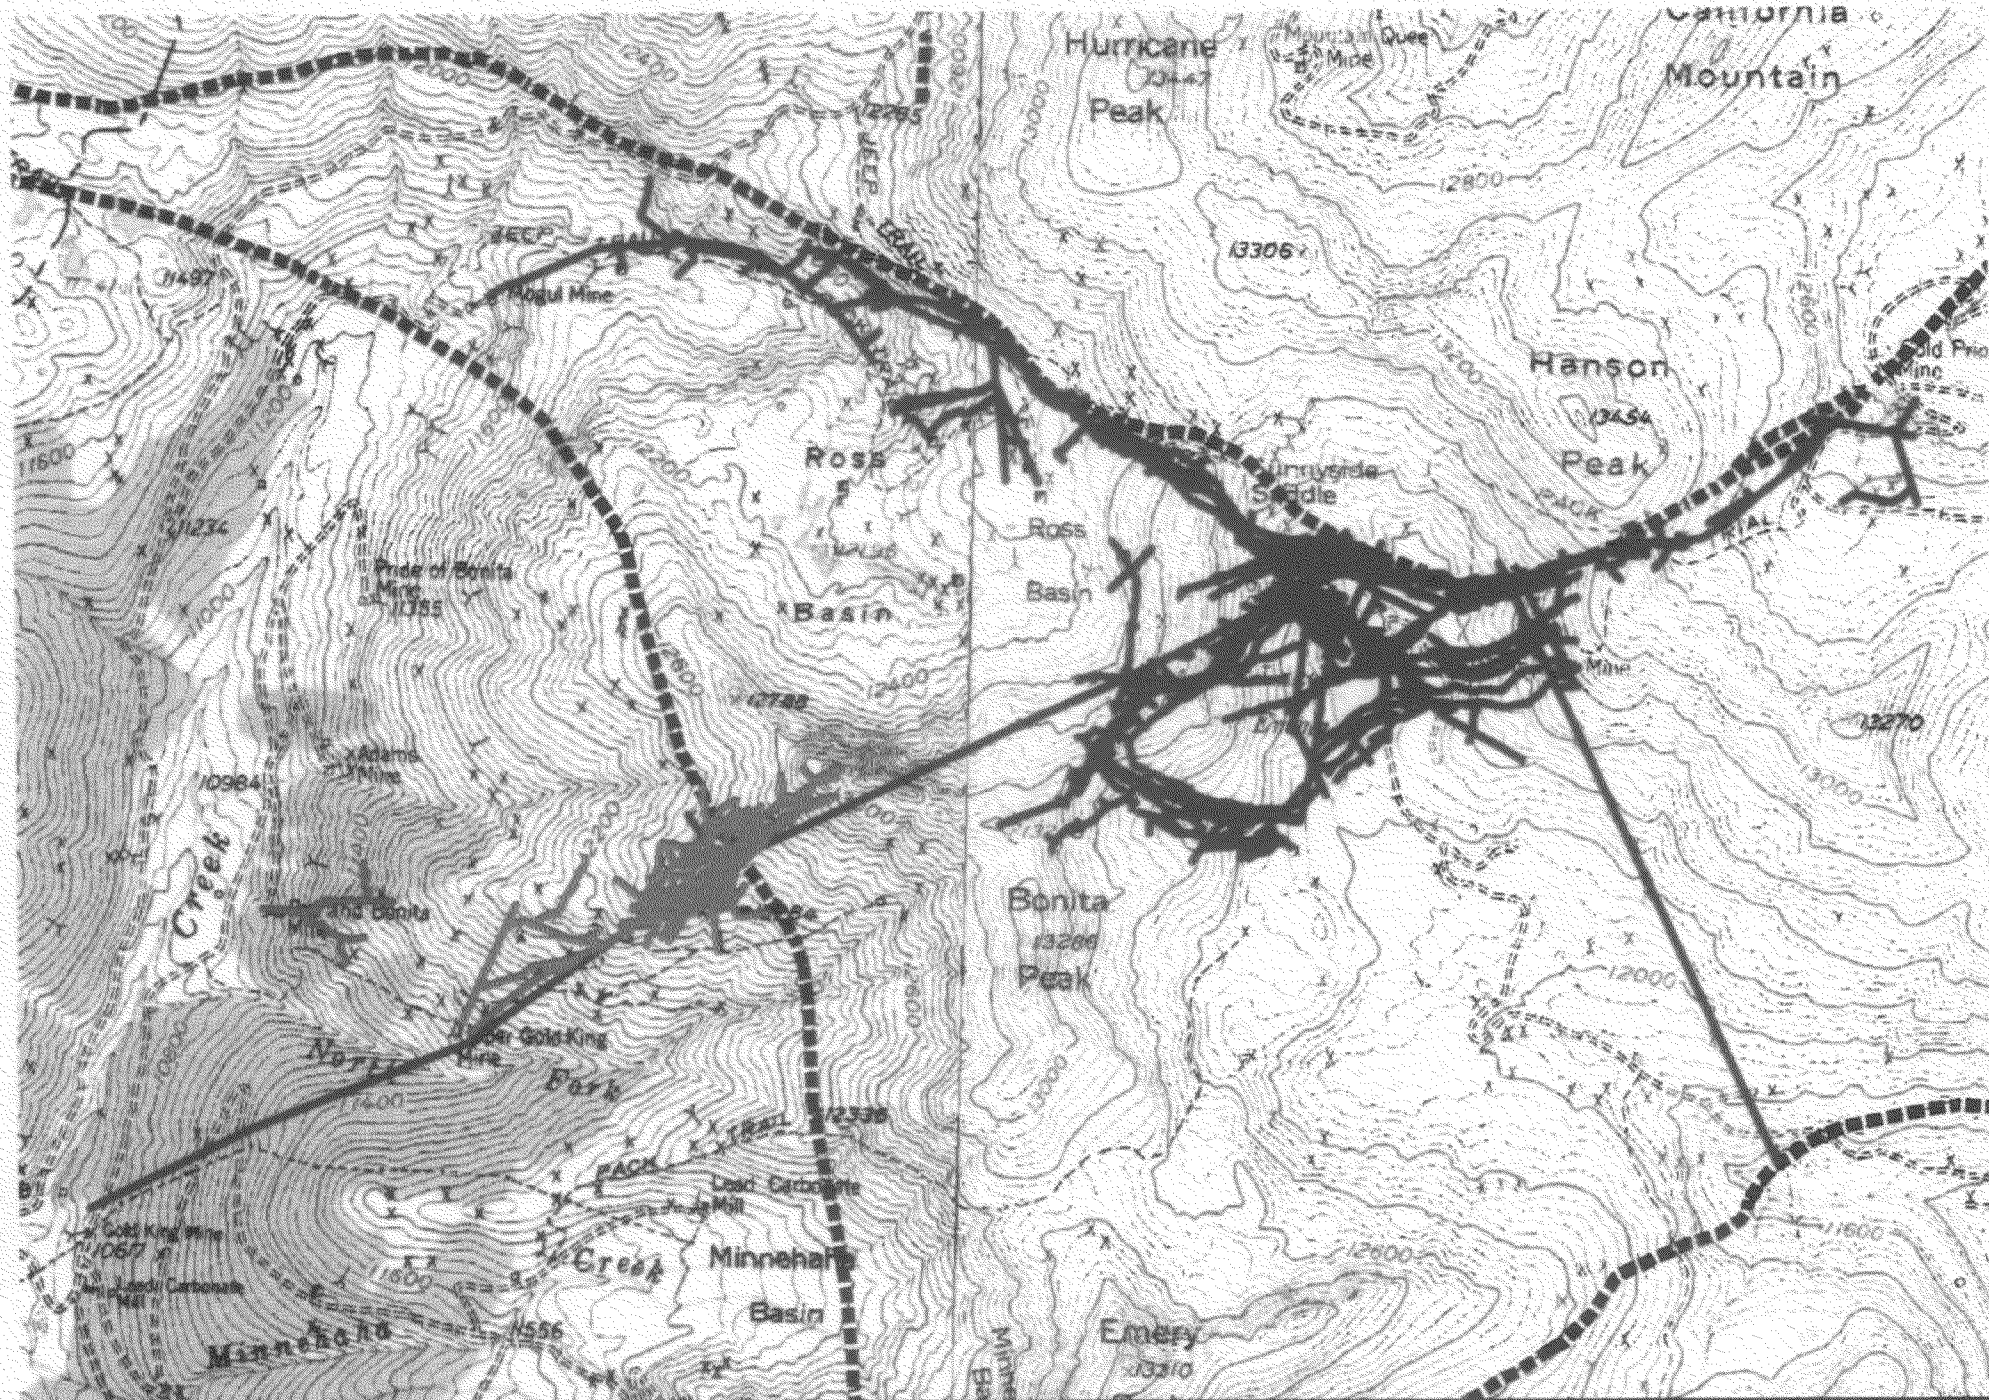
repared by Kirstin Brown, CDRMS, 1/21/2014

information and the estimated waste dump volumes, it is estimated that there are only approximately 3,500 feet of underground workings and that the adit does not connect to other mines (Figure 3). In addition, there is no mapped surface opening to the mine and none were found during Site investigations in September 2014 or previously.

RED AND BONITA MAP
 Mine Workings past cave-ins are only projected to line of sight
 SUNNYSIDE WORKINGS
 Most Recent workings, needs more work
 GOLD KING WORKINGS

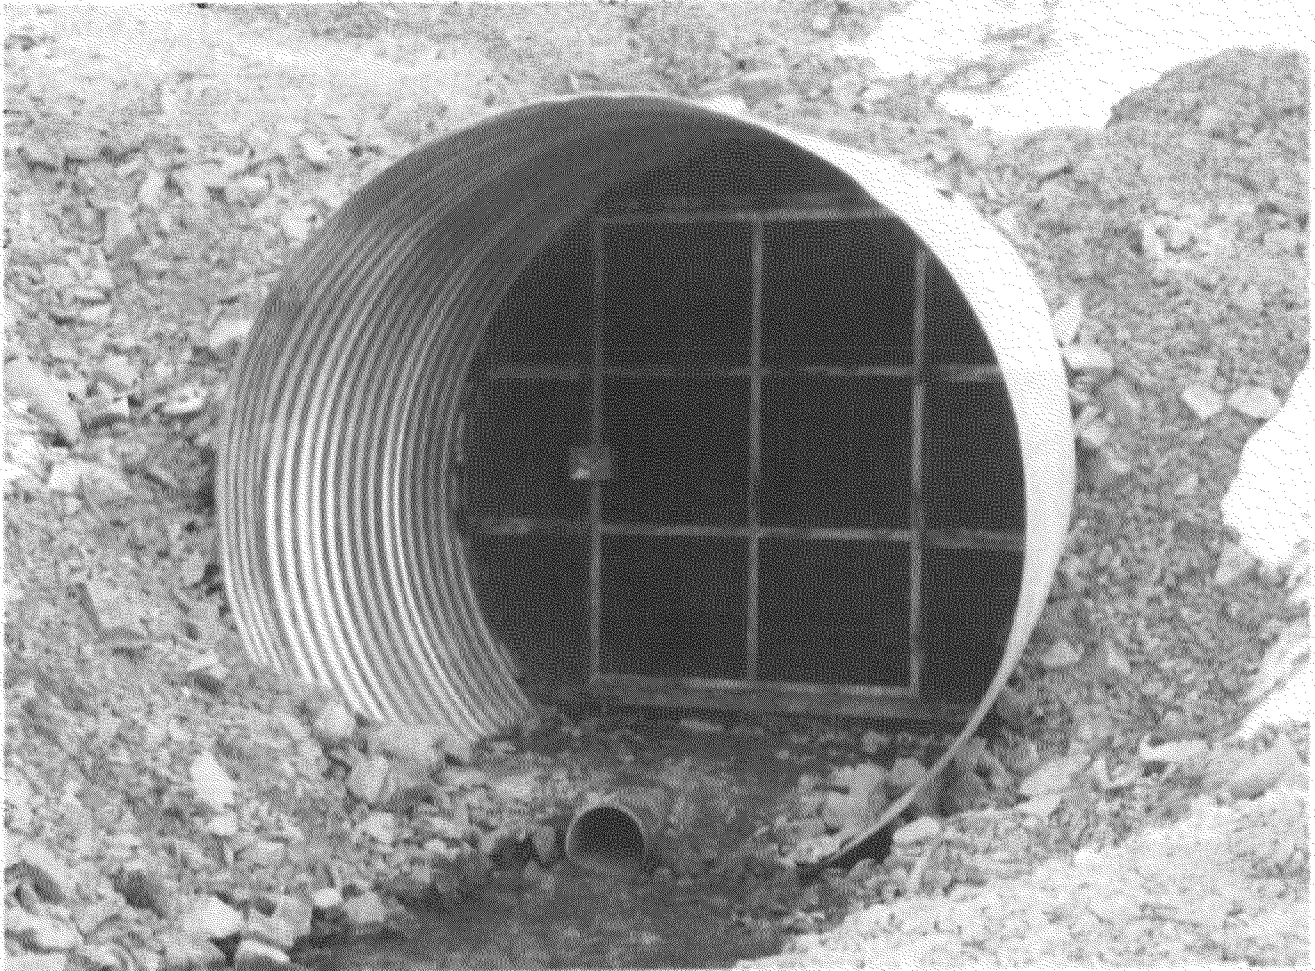
Red and Bonita Mine portal

EPA installed a new portal structure in October 2011 after removing 30 feet of blockage at the adit entrance. Adit discharge flows overland across, and approximately 200 feet down, a mine dump face before being channelized at the toe of the dump. The channel directs flow into an iron bog en route to Cement Creek approximately 500 feet down gradient of the toe of the dump.
